**A BRIEF BUILDING RECORD OF  
82 CHURCH STREET (CRAIK HOUSE),  
TEWKESBURY, GLOUCESTERSHIRE**

**Report: GBRG0237**

**Gloucestershire Building Recording Group**  
[www.buildingarchaeology.org](http://www.buildingarchaeology.org)

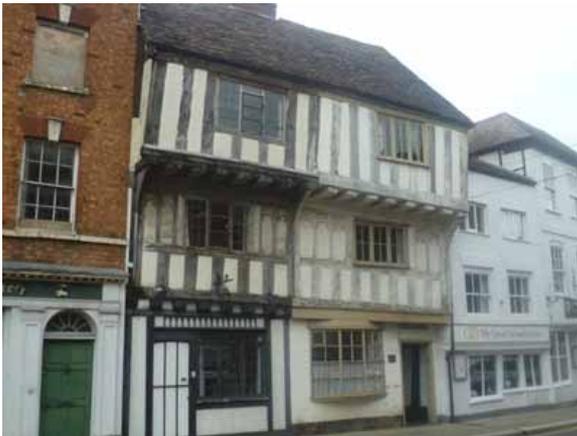
**Figure 1: 82 Church Street (left) and 83 Church Street (right)**

The externally visible wall-frame consists mainly of close studding, but the front face of the first floor has close studding with a mid rail (**Figure 1**). The gabled ends in the roof are likewise close studded (**Figure 3**), but there are small square panels to the rear. There are large passing curved braces (**Figure 2**) and jowled posts. Both the first and second floors are jettied to the front, with plain jetty brackets which abut buttress shafts (**Figure 7**). The joists are set flatways. Surviving tracery (**Figure 8**) indicates that the first floor above the rail was windowed across the full width of the two bays. The second floor jetty bressumer is moulded and heavily decorated (**Figure 8**).

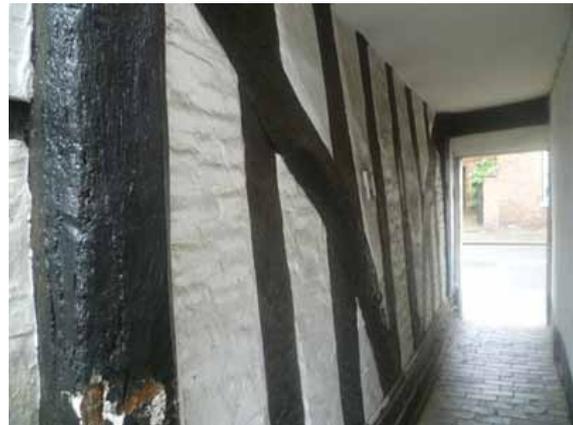
An exceptionally fine and well-preserved town house stated to be late C15 or early C16 in date (Historic England List No: 1205867). Numbers 82 and 83 Church Street together form a three-storey building consisting of a 2-bay front range which runs east-west parallel to Church Street (**Photo 1**) with a side passage to the east. To the rear survives a single bay (of a possible originally 2-bay) rear range that runs north-south. The timber trusses of the front range have been labelled from A in south-west corner to C1 in the north-east corner and the rear range from D in south-west corner to F1 in the north-east corner (see APPENDIX I for the plan). Numbers 82 and 83 Church Street are owned separately and only number 82 was accessed and recorded in this report.

**Figure 2: Side passage of 83 Church Street**

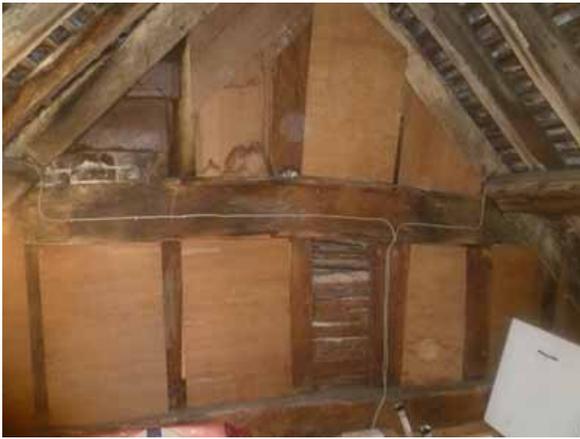
This 2-bay, three-storey building is of box-frame construction. The timbers in the roof are lightly smoke-blackened suggesting that the building was partly open-halled or possibly heated with braziers. The roof is gabled (**Figure 3**) and has three studs in the central truss between the collar and tiebeam (**Figure 4**). Both the collars and tiebeam are cranked. The roof is of clasped purlin construction with curved wind braces (**Figure 5**). The rafters are set flatways and pegged (**Figure 6**).

**Figure 3: Gabled roof**

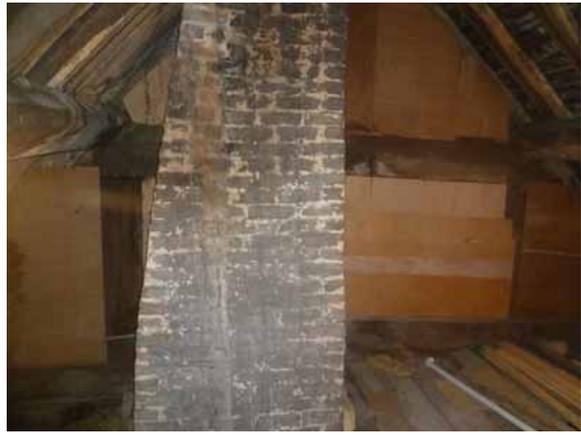
**Figure 4: Three queen strut central truss**

Examples of the use of curved passing braces or flat step stops (**Figure 13**) have so far been recorded in buildings dated before the 1520s. The use of plain jetty brackets (**Figure 13**) appears to be an early feature and has been recorded on two tree-ring dated buildings in Tewkesbury: 39-45 Church Street (dated 1409) and 66 Church Street (dated 1475). The use of tracery also appears to be an early feature and has only been identified on buildings before the 1470s. While previously examples of the three queen struts roof truss were

thought to generally occur after the 1600s, recently an early example has been identified in Herefordshire that is tree-ring dated to 1467. From the stylistic features currently identified a date of construction between 1420s and 1470s is suggested for the front range. Too few stylistic features were recorded for the rear range to establish a date estimate.

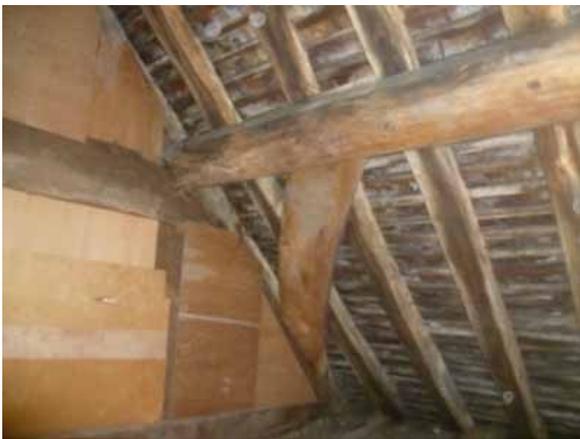
**Figure 5: Curved wind braces**

The smoke-blackened rafters in the roof identify this as an open hall building and so likely built before the 1540s. Many of the stylistic features including the flatways rafters, curved wind braces, close studding and trestle sawn timbers all indicate that the building was constructed before 1540, but do not help to further narrow down a date for construction.

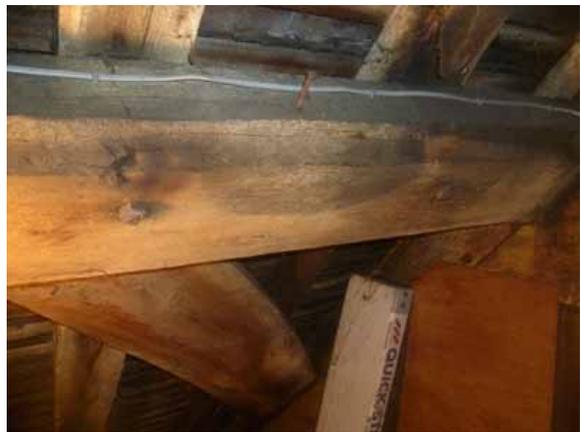
**Figure 6: Rafters pegged to purlins**

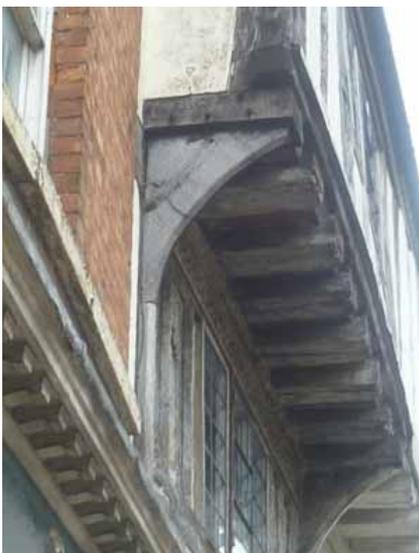
**Figure 7: Jetty with simple jetty brackets on buttress shafts**

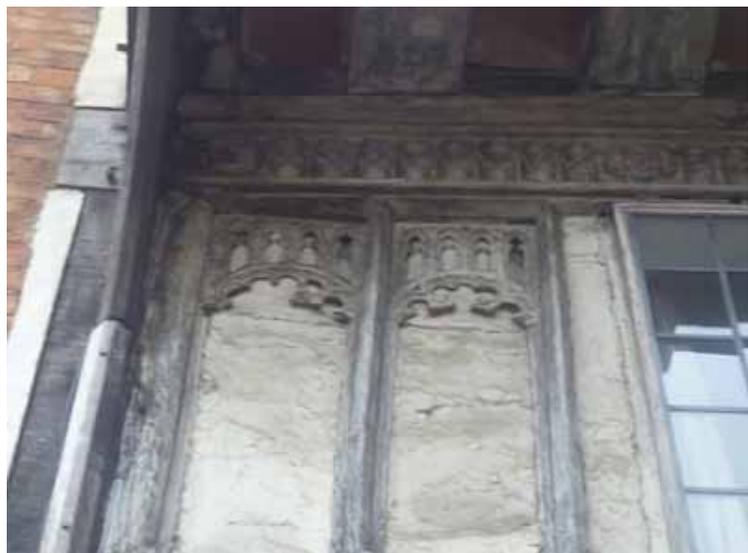
**Figure 8: Window tracery with moulded and heavily decorated jetty bressumer above**

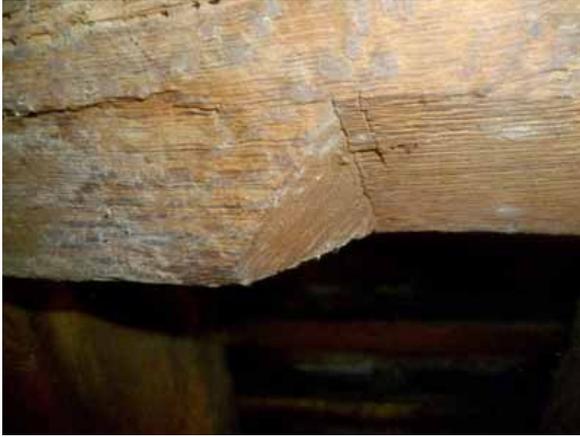
Internally there are flat (also called straight) stops on the purlins (**Figure 9**). The timbers show signs of being trestle sawn, but no carpenters' marks were observed. The first floor joists were once painted with a black chevron pattern (**Figure 10**).

**Figure 9: Straight stop**

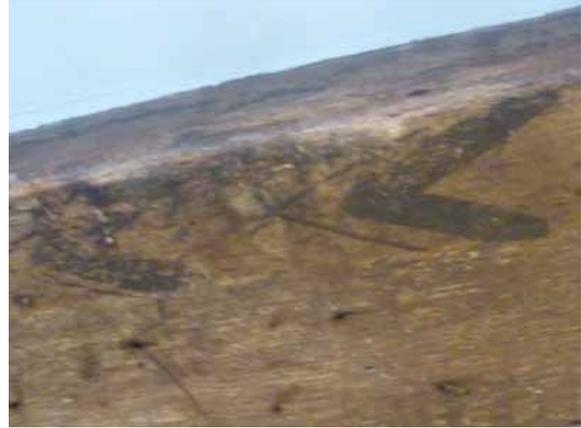
**Figure 10: Painted timbers in chevron pattern**

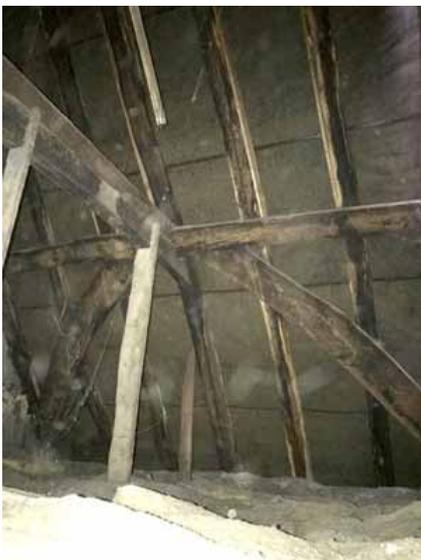
One bay appears to survive of a possible 2-bay rear range of box-frame construction. The timbers in the roof are heavily smoke-blackened identifying it as an open hall or kitchen (**Figure 11**). The roof is gabled and has a single tier of clasped purlins. The wind-braces are curved and the rafters laid flatways.

**Figure 11: Smoke-blackened roof timbers**

One bay of a possible once 2-bay rear range was also observed. The timbers in the roof are heavily smoke-blackened suggesting it was an open hall or kitchen, but too few timbers were observed to establish a date estimate, or to identify its dendrochronological potential.
